# REPLACEMENT OF POND 1 WELL PUMP AND DROP PIPING

MAY 7, 2021

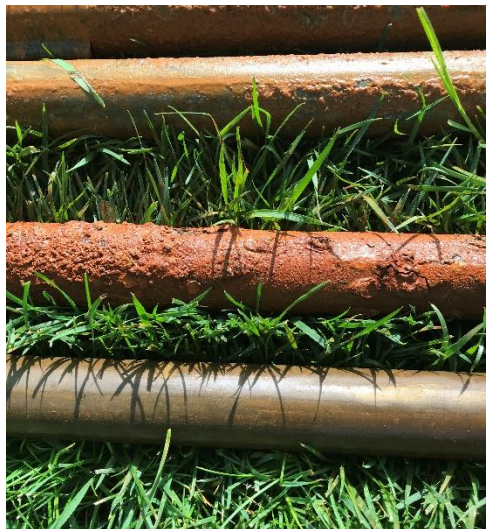
The galvanized pipe sections exhibited vastly different patterns of corrosion.

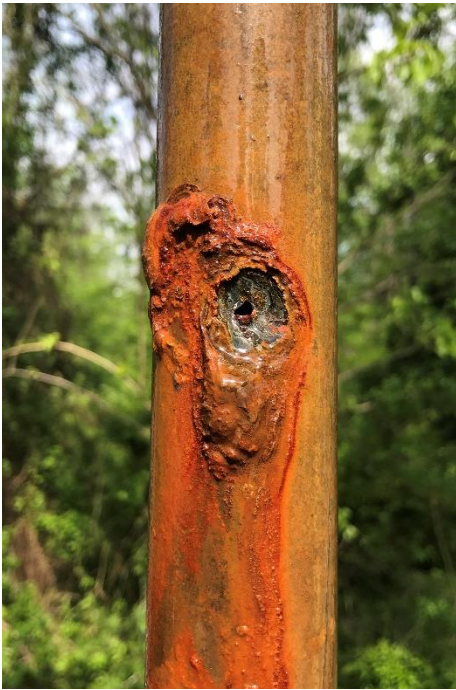
One of roughly half dozen corrosion leaks. These clearly contributed to the 2020 irrigation pressure deterioration.
