RAP POND 4 – REPAIR OF OUTLET STRUCTURE LEAK

AUGUST 20-21, 2022

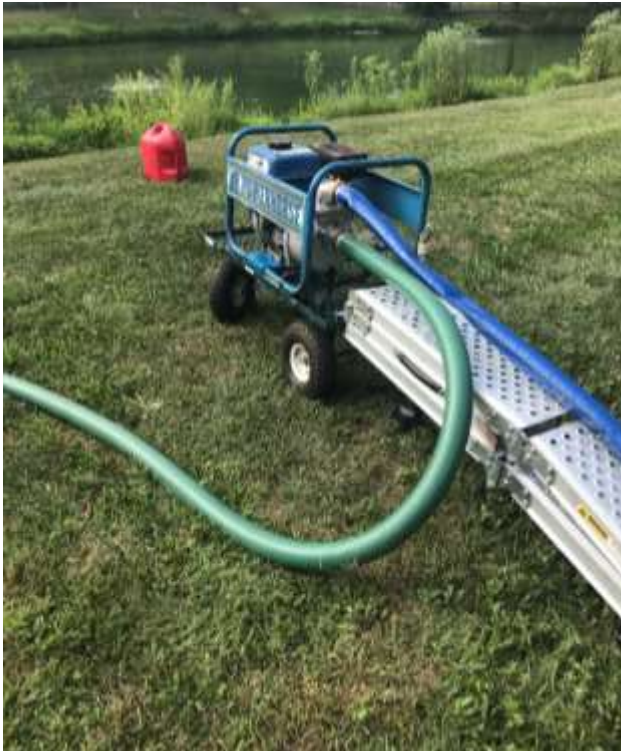
The pond level was lowered using a gasoline-powered, 2" trash pump rated at 130 gallons per minute. It was discharged (blue hose) into the drainage easement north of the pond.

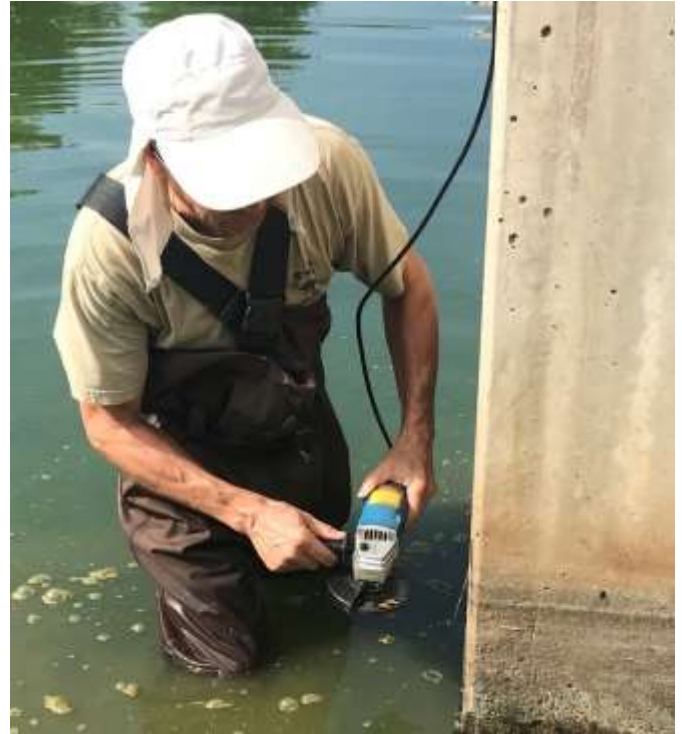
After wire brushing the joint, an angle grinder was used to clean out old grout and provide a cavity for the hydraulic cement.

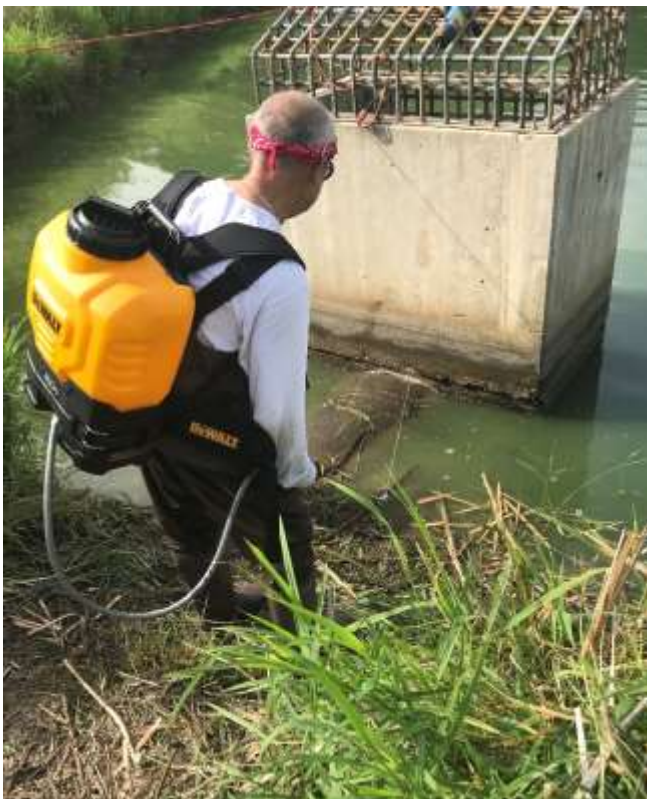
The ground-out joint was flushed with clear water from a backpack sprayer.

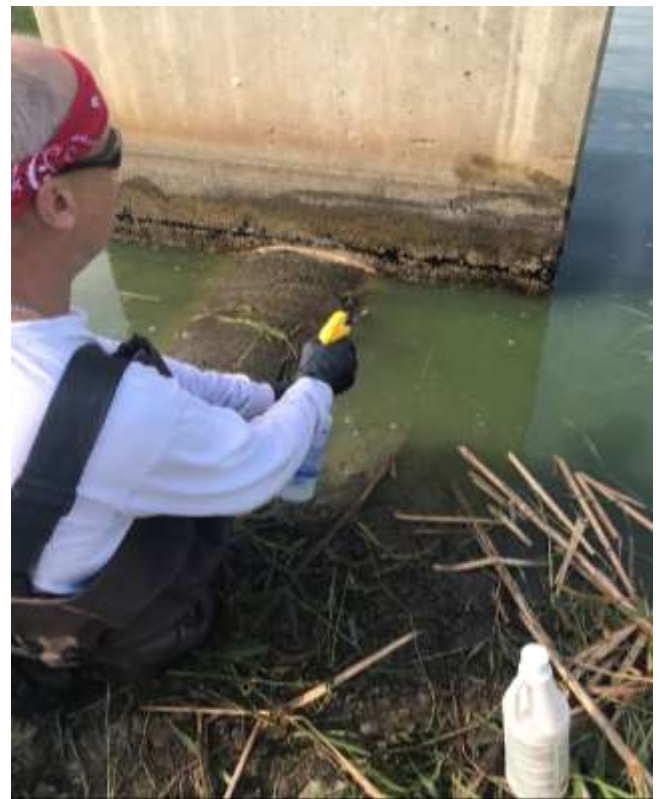
Acid etching the joint with dilute hydrochloric acid dissolved contaminants, creating a better bonding surface.

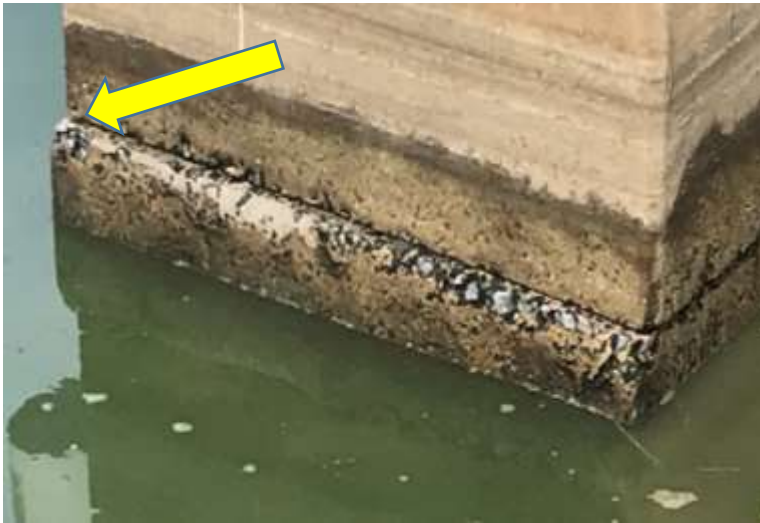
It is worth noting that the top pre-cast section of the structure is not perfectly aligned with the section beneath it, creating a slight over-hang on one side and under-hang on the opposite side. The receding water level also revealed that the entire structure is not quite level, possibly from settlement. Neither of these minor conditions should effect structural integrity, but could have contributed to initiating the leak.

After rinsing out the acid, neutralizing the surface with ammonia and a final water rinse, all four sides of the joint were ready for grouting. Note the misalignment of the stacked sections evident at the left hand corner of the structure.

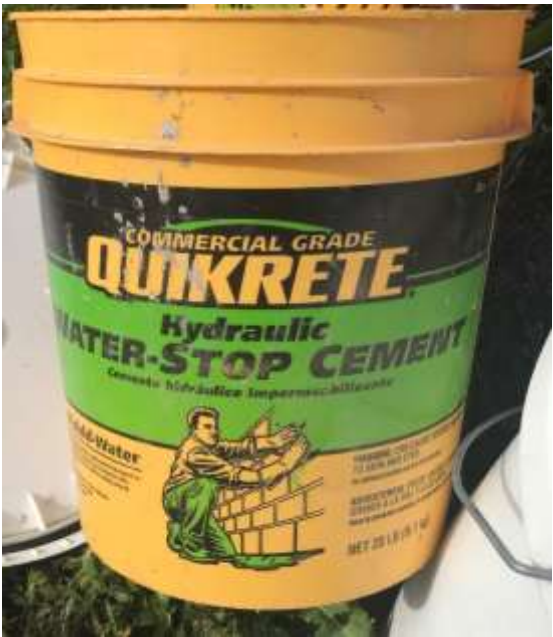
The hydraulic cement is a rapid setting, high strength repair material designed to plug leaks in concrete and masonry.

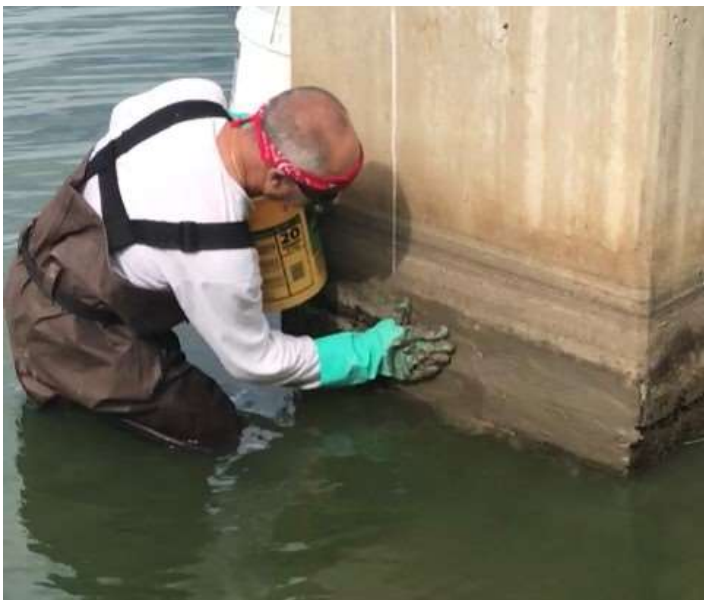
After hand mixing the cement with water Ed worked quickly to stuff the joint before the material set up. The first pre-weighted packet of grout was enough to cover the area shown.

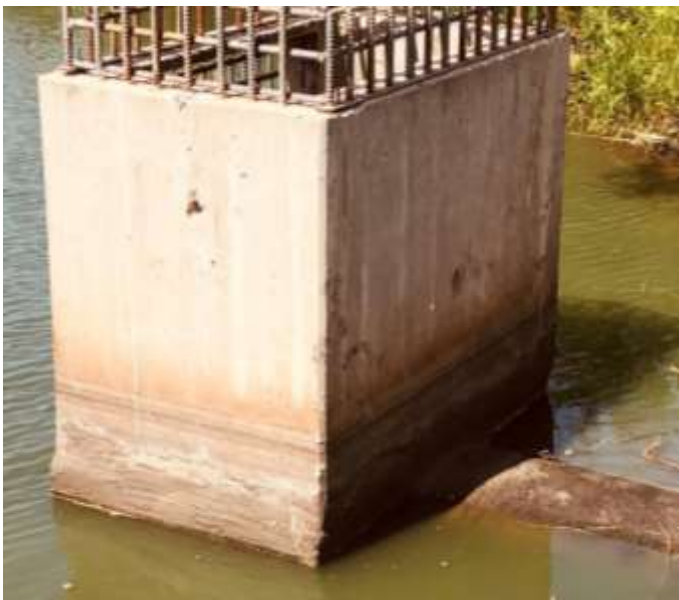
With the repair project complete the pond will gradually refill from precipitation as well as operation of the well pump.
