# RAP Phase I Stormwater System Internal Survey And Repairs - March/April/May 2024

## Purpose of Survey

The Phase I roadways – Fairmount Boulevard, Sloan Road and Thayer Way – as well as the clubhouse parking lot are to be repaved in the spring of 2024. The firm advising the community on this project, Bustamante Engineers, recommended that an internal inspection be performed of the stormwater system located in and beneath the paved areas to identify any areas in need of repair prior to the repaving.

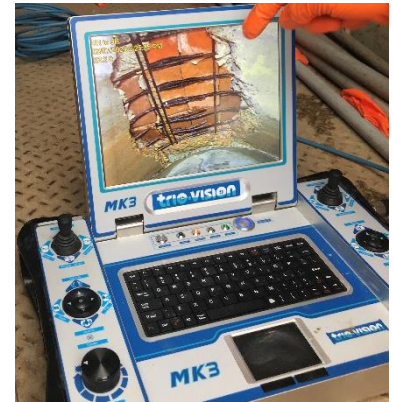
Image of pipe damage under Sloan Road

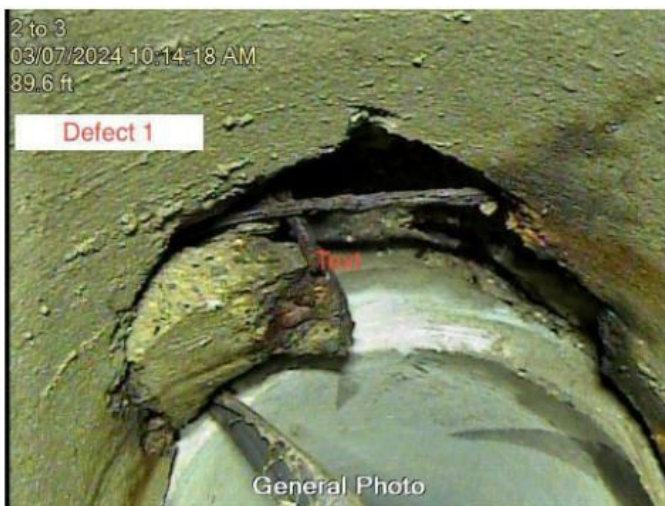
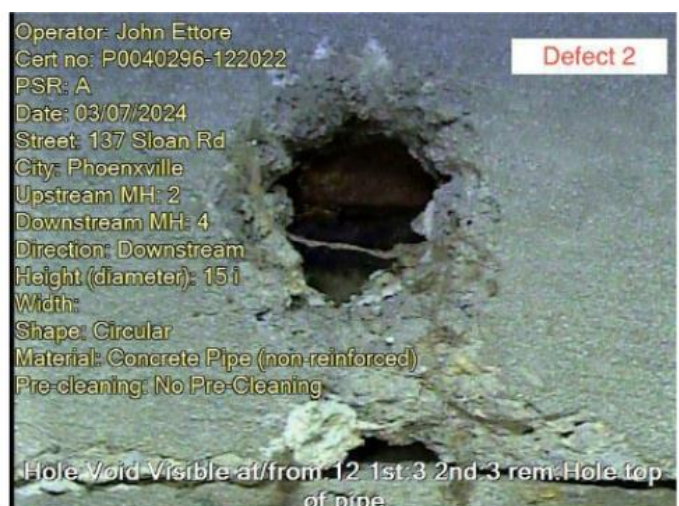
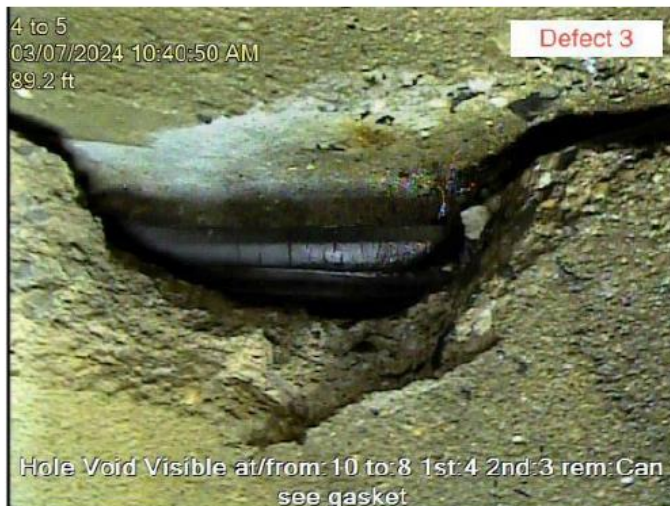
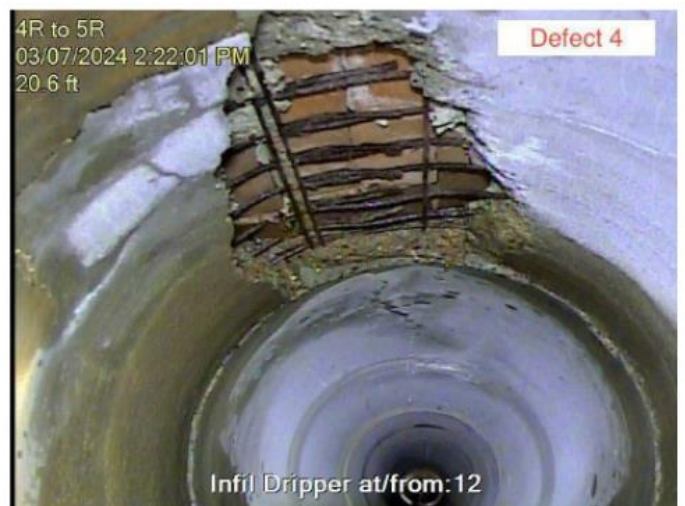
A preliminary report from Delco indicated that four areas of the Sloan Road stormwater system were recommended for repair. The following are screen shots from the inspection video depicting the nature of the internal pipe damage at each of the locations. The first three are located in 15" diameter pipe under the western portion of Sloan while the fourth defect is in 24" diameter RCP under the eastern portion of Sloan.

Delco recommend that each area of damage be repaired with an internal four foot long resin-impregnated fiberglass/felt sleeve. This form of “trenchless” repair eliminates the need for excavating the damaged pipe and reduces both time and expense. When properly installed the expected life of such sleeves is 50 years. Delco’s quoted price for the work was \$5,120 per defect for a total of **\$20,480**. If done separately on different dates the cost of each repair would be \$6,945.

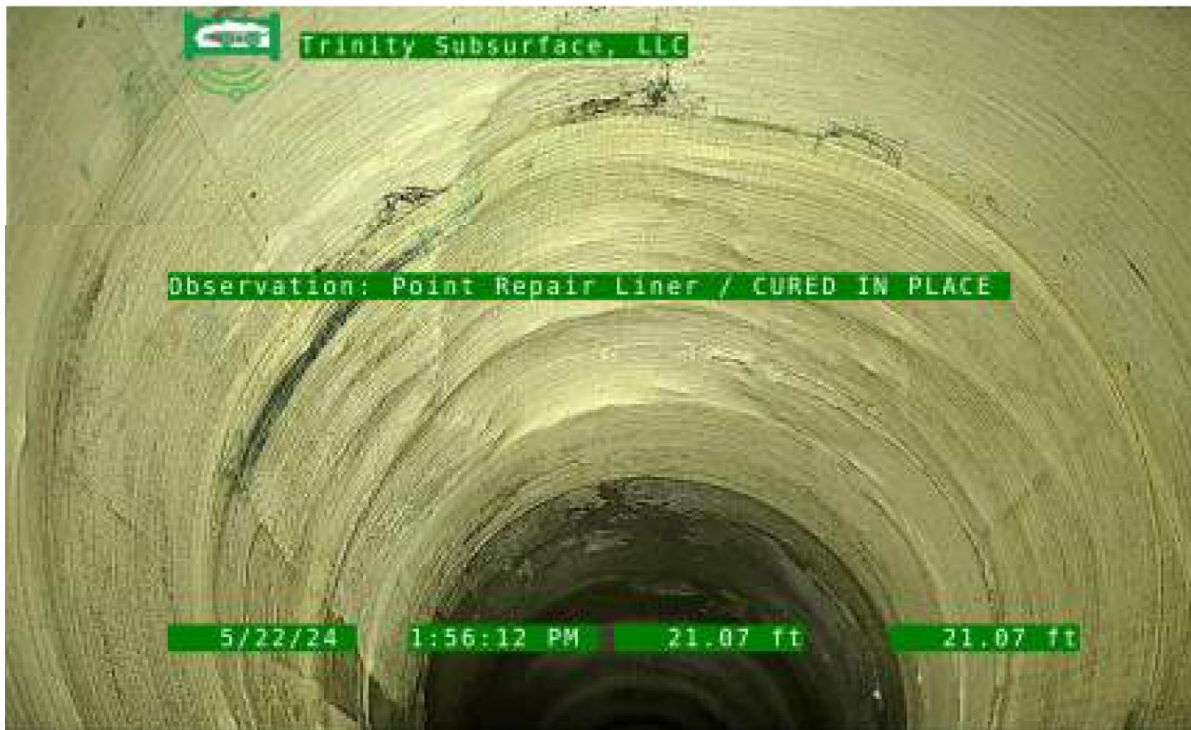
Following removal of the packer at each location a final CCTV inspection revealed that the three defects under the western section of Sloan Road were properly repaired. However, the 4 foot long repair sleeve in the 24" diameter line under the eastern section of Sloan did not completely cover the damaged area (depicted as "Defect 4", on the third page of this report). This was likely caused by the repair sleeve slipping on the packer as it was dragged into position in the pipe. A second, overlapping repair sleeve was successfully installed, as confirmed by a final camera inspection, an image of which is shown below.
