RESERVE FUND ANALYSIS UPDATE

REGENCY AT PROVIDENCE

PREPARED FOR:
REGENCY AT PROVIDENCE COMMUNITY ASSOCIATION

DATE:
OCTOBER 19, 2021

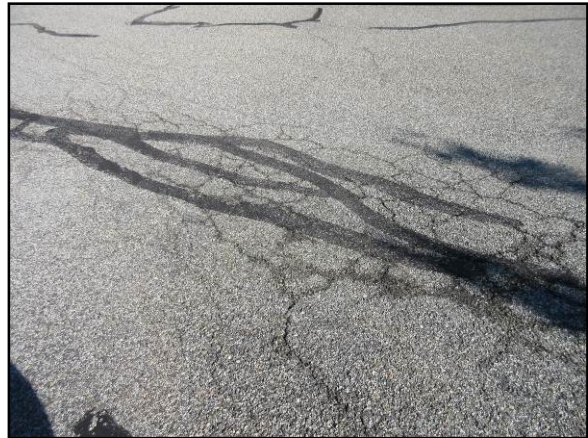
The condition of the roadways varies greatly between phases. The roadways in Phase IV were in the best condition with only a few lateral cracks present. Hanover Road in Phase II has the start of spider cracking in multiple locations and alligator cracking near the curbline, particularly at 200-202 and 249. Phase III roadways have some lateral cracks and repeated locations of spider cracking at the ends of driveways. Lastly, Phase I roadways have alligator and spider cracking throughout, areas where minor potholes are starting to form and some settling around the inlets.

The estimated life expectancy of the roads and parking lots is 20 to 25 years. Replacements have been planned based on the above conditions.

1. Milling the asphalt surface a depth of 2"
2. Applying at minimum 2" of asphalt wearing surface course

Future maintenance of the roadways consists of sealing open cracks and patching potholes. As replacement of the wearing course is upcoming on the Phase I roadways, we have lowered the quantity on the line item for Asphalt Patch & Repair.

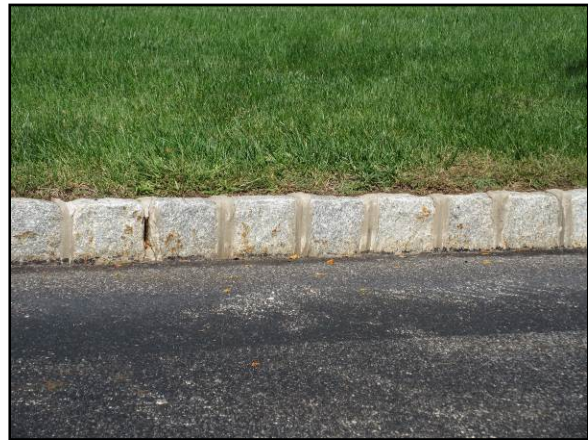
The curbing for this community consists of Belgian block set inside a concrete foundation. This type of curbing is durable and does not require extensive maintenance other than occasional repairs, especially after the wintertime when snowplows tend to cause damage. Typical maintenance includes reparging between the granite blocks when the mortar joints become loose or they fall out and resetting individual blocks that become dislodged.

In the Reserve Fund Analysis, we include partial curbing replacements, as total replacement is generally not needed. During our second site visit, a company was onsite performing repairs on the curbing. As repairs and replacements were being performed on the curbing at all phases, we continue to keep this item as one line item instead of a per phase item.

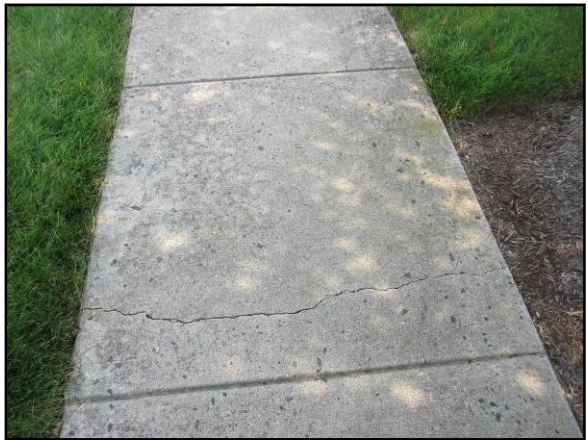
1. Settlement/heaving when one edge is higher than the other. When the elevation difference between the adjoining surfaces is 1/2" or greater, it should be replaced for pedestrian safety reasons.

2. Excessive cracking
3. Open joints of walkways and steps
4. Spalling; surface erosion

We noted areas with severe spalling, several cracked panels of sidewalk, and areas where the sidewalk has an uneven walking surface.

Associations rarely do complete replacement in the case of sidewalks. Therefore, in the Reserve Analysis, we include partial concrete flatwork replacements on a six-year basis. Next concrete replacement is scheduled for in the next year (2022).

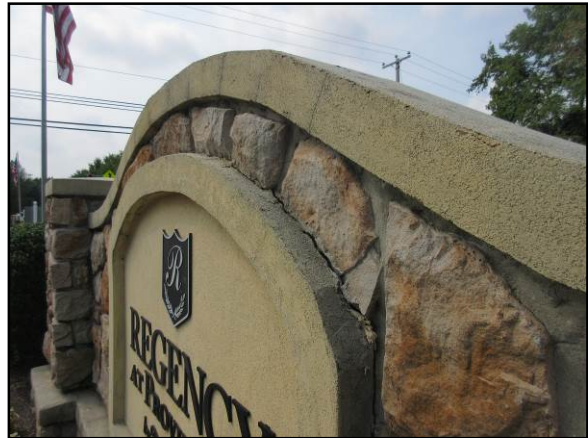
We noted multiple cracks and areas of loose joints with the mortar that should be repointed on all three signs. We noted some of the metal letters at Phases II & III are loose and should be resecured. Additionally, the insert on which the letters are mounted at Phase I is loose and should be reattached to the stone wall. We would consider these items to be maintenance related. Pointing should be paid for under the operational accounts and not from the reserve account. In the reserve fund we include costs to replace the letters and the portion on which they are mounted.

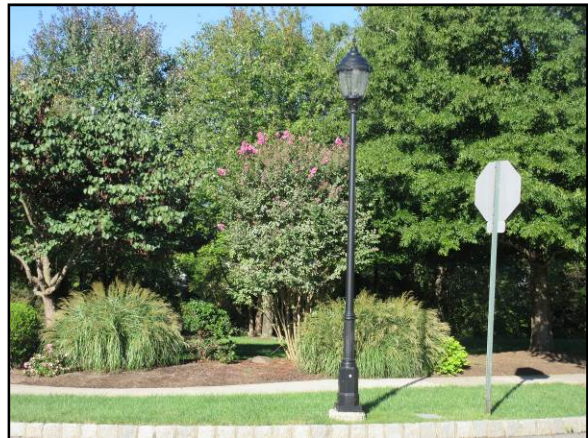
We noted some areas of chipped paint on the bases, likely due to impact damage from landscaping equipment. This is strictly cosmetic in nature.

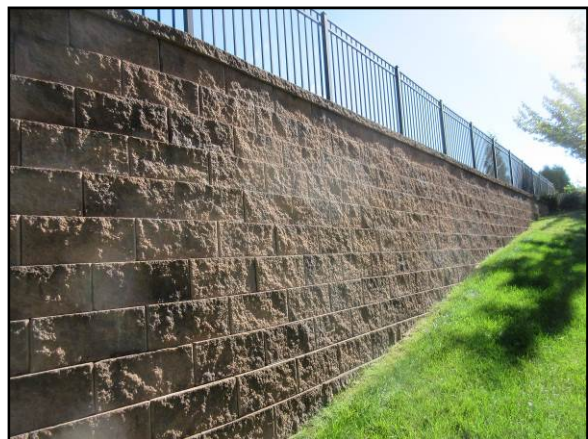
Partial replacements for the landscape block retaining walls are included in the reserve fund analysis. If constructed properly, they should have a 40 to 50-year service life.

1. Resetting the coping and capstones
2. Resetting fencing
3. Correcting soil washout above the wall

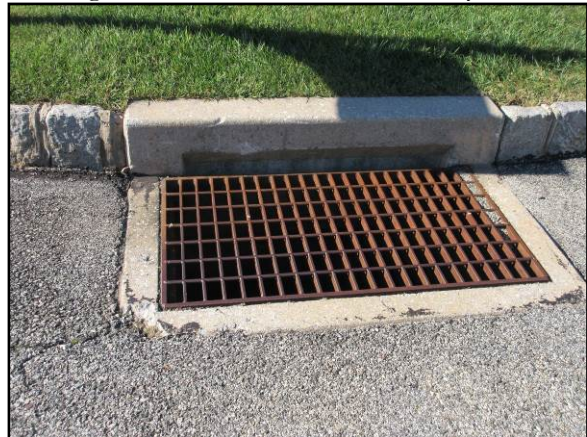
In the case of inlet tops, prior to repaving of the roads, the damaged inlet hoods should be replaced since they tend to deteriorate from snow plowing and deicing salts. At the same time, repairs can be performed on the interior of the inlet.

We noted a hole in the pavement next to the inlet top to the right of 518 Logan Road, along Peters Way.

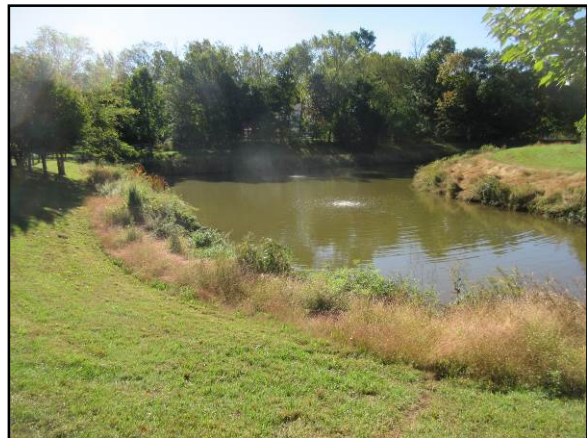
There are multiple stormwater management ponds within the community. It is important that the stormwater outlet controls are kept clean and fully operational. The minimum maintenance procedures should include the following:

1. Cleaning of the inlet and outlet controls
2. Trimming or removal of unwanted vegetation, including trees and saplings (not wetlands)
3. Removing excess sediment
4. Yearly inspections of the berms and outlet control devices

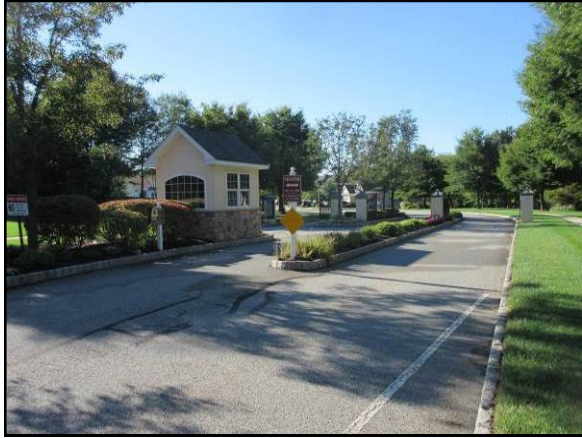
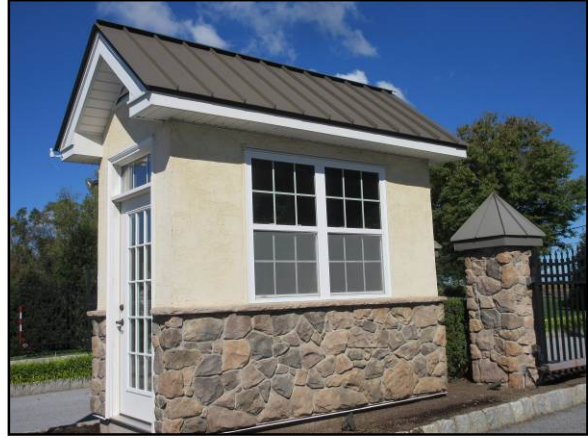
We continue to reserve for the gate actuators, the gates, including renovation to the pillars and a renovation fund for the gate houses.

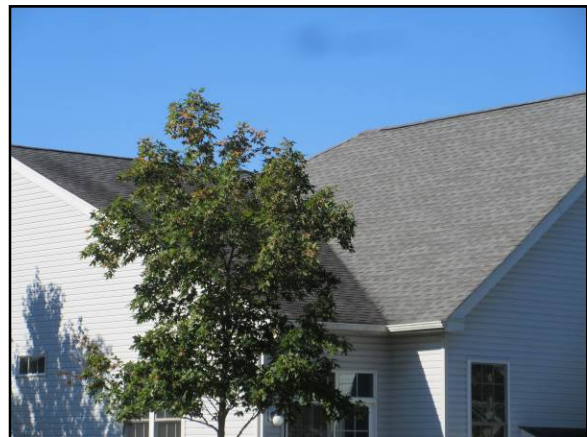
Reportedly the roofing for 173 buildings was replaced prematurely due to storm damage. The reshingling project occurred in 2021 and included 44 units at Phase I, 29 units at Phase II, 44 units at Phase III and 56 units at Phase IV. The shingle used during this project is reportedly an Owens Corning shingle that has a 50-year warranted life. These roofs have been included as a separate line item in the reserve study and assigned an estimated useful life of 45-years. Pricing was provided from the Association and is based on the actual cost of replacement. Warranties of the shingles should be kept inside the management office.

Asphalt fiberglass shingles do not require significant maintenance if they are installed properly and are of higher quality. Attentive repairs are needed, especially after storms where, occasionally, shingles will blow off or become loose. Typically, leak points of any roof are at the roof penetrations, sidewalls, along valleys, skylights, and in front of the gutters.

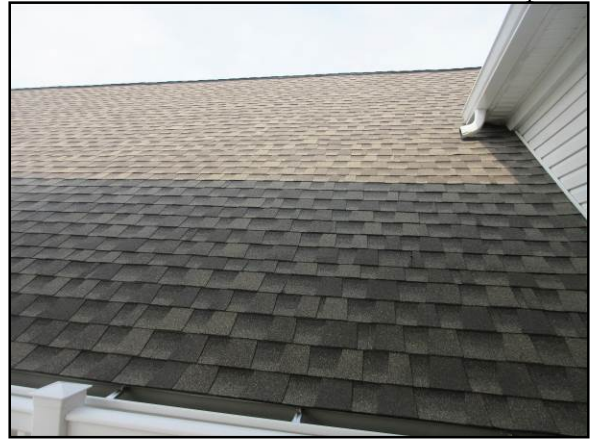
We continue to include replacement costs for the roofing, gutters and downspouts, stone veneer, painting of the fiber cement trim and siding on the exterior of both clubhouses. As complete replacement of the stone veneer should not be needed, the cost is for partial replacement and repointing. It should be noted that both clubhouse roofs were replaced in 2021 due to storm damage and not from premature deterioration of the shingles. The shingles used are manufactured by Owens Corning and have a 50-year warranty. An estimate useful life of 45 years has been assigned on the shingles. Cost for replacement of the roofing was provided by the Board.

We noted many rusted nails holding the composite decking in place. This condition should be watched for future nail pops and loose boards. Typically, composite lumber is to be fastened with stainless steel screws; however, it does not appear that stainless steel screws were used in all locations by the builder.

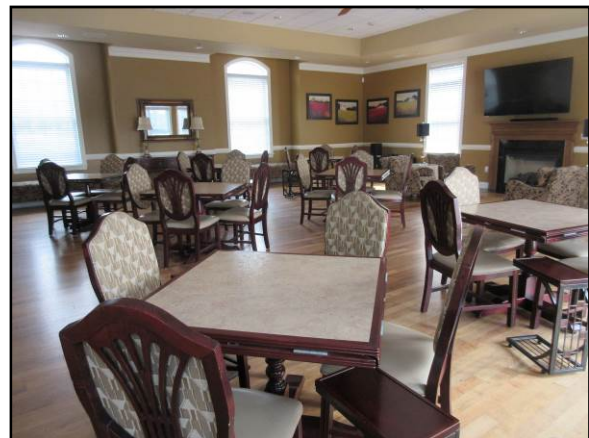
The estimated useful life of the floorings can vary depending on the usage within the clubhouse. Remaining life could be longer than what is scheduled in the study. Reassessment of the flooring should take place with each reserve study update. We noted some scratches on the wood flooring in

the great room but, in place of premature replacement, the Board may want to consider having the floors buffed.

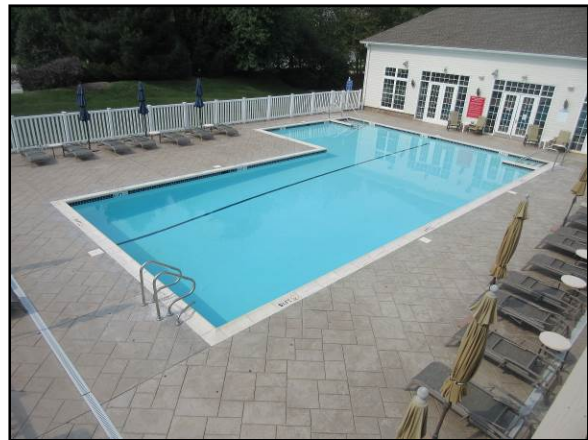
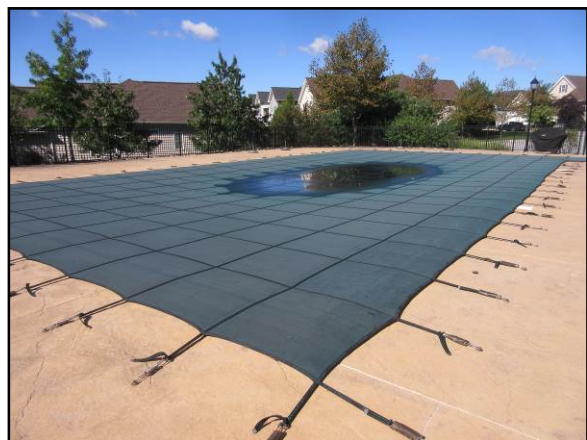
With both pools, replacement of the pool structure is not assumed over the study period. However, we estimate replacement of the pool equipment (pumps, filters, and cover), replastering of the pool, replacement of coping & tiling, pool furniture and partial replacement of the concrete decking.

The concrete decking is in good condition with little to no cracking or settlement noted at either pool area. Any concrete that poses a tripping concern to the users of the pool area should be replaced. Partial decking replacements for both pool areas have been included in the reserve fund study.

The perimeter pool fences serve to prevent unwanted or accidental entry into the swimming area. As with any special equipment, pools need to be operated properly and safely. The white vinyl fencing at Phase I and the black metal fence at Phase IV have both been included for replacement in the study with replacement in year eleven (2033) and twenty-one (2043) respectively.

Lastly, we recommend the Association have the swimming pools and equipment serviced, including the pumping, filters, and electrical equipment at least once a year. All GFCI switches should be checked as part of this inspection.

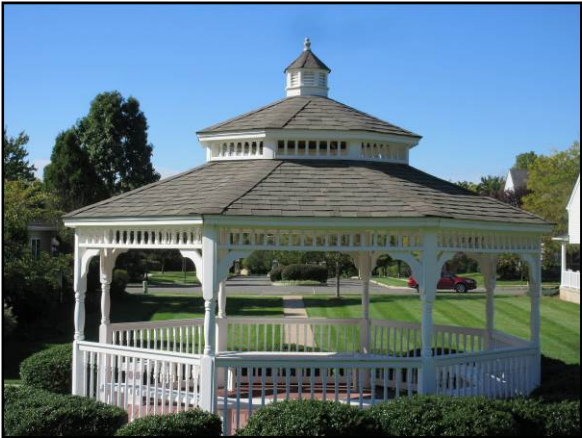
At the center of Phase I is a lone gazebo. Overall, the gazebo is in fair condition. The flooring appears to be in fair to good condition. Instead of complete replacement of the structure, which should not be needed, we included a renovation fund to replace components as they weather.

Renovations are planned for in year seven (2029). There is some staining of the interior roof structure and if the Board is aware that the roofing is leaking, they should let us know so renovations can be adjusted.

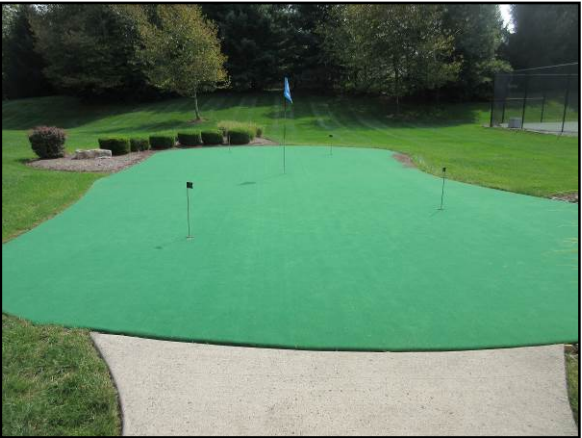
On the eastern edge of the Phase I Clubhouse parking lot is a putting green. The item was replaced in 2021 and is in very good condition. Putting greens have an estimated useful life of 15 years. Replacement has been planned for in year fifteen (2037).

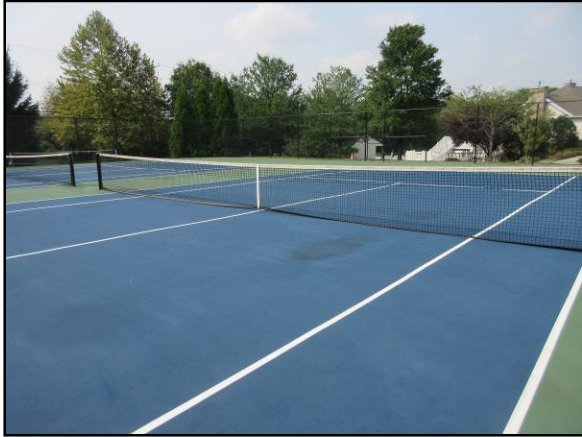
Adjacent to the putting green, on the eastern side of the Phase I Clubhouse is a double tennis court. In the reserve fund analysis, we included costs for recoating the surface and for the eventual replacement of the entire court. As with any asphalt component, crack sealing is extremely important in maintaining the courts.

We noted a few areas that appear to hold water and a couple minor cracks in the surface. The sand coating and striping appear to be in good condition.

Recoating the surface, with a non-slip coating that contains sand and striping every 8 years or so is industry standard. Based on our review, recoating the tennis court has been scheduled for in year six (2028). Replacement of the surface, including some full removal, is expected within the next 14 to 15 years.

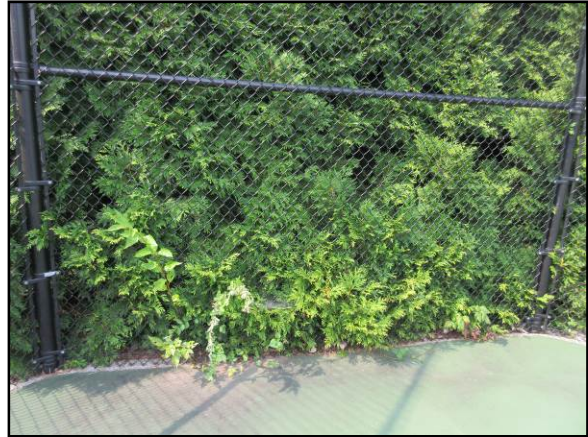
We also include replacement costs for the 10 ft. high chain-link perimeter fence. Fencing of this type has a 25-year estimated useful life with anticipated replacement occurring in year thirteen (2035).

We suggest cutting the brush and vegetation that is overgrowing the fence in order to help it reach its full estimated useful life.

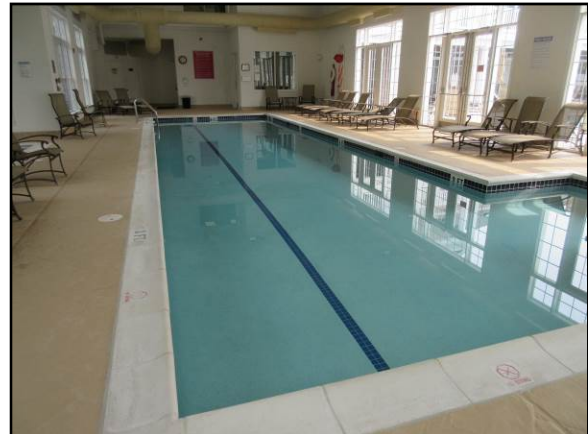
At the Phase I Clubhouse, on the ground level, is an indoor pool and spa. As with the outdoor pools, we include replacement costs for replastering of the pool, the coping & tiling, the concrete decking, water heater, filter, and pumping equipment.
