## REGENCY AT PROVIDENCE - DESCRIPTION OF COMMUNITY PONDS

### **POND 1**

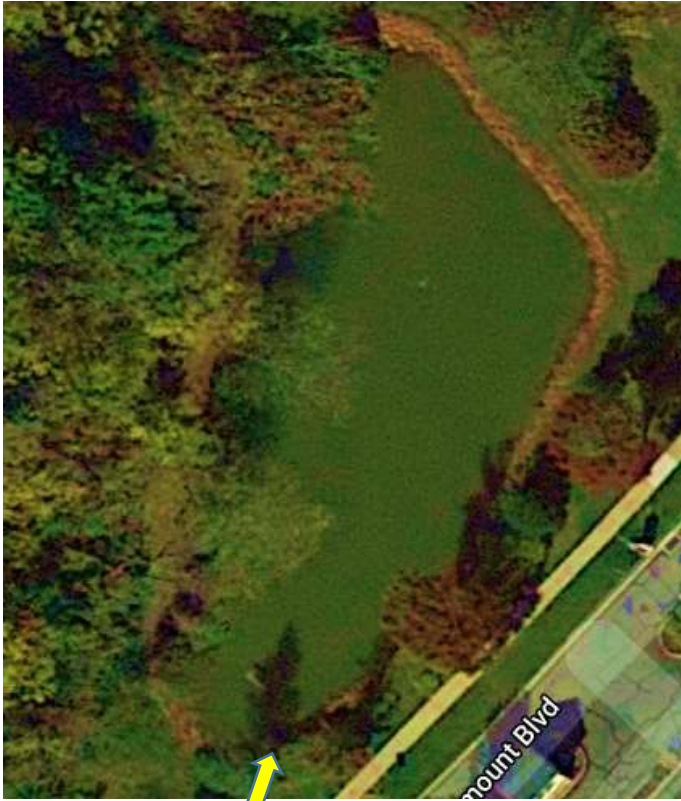
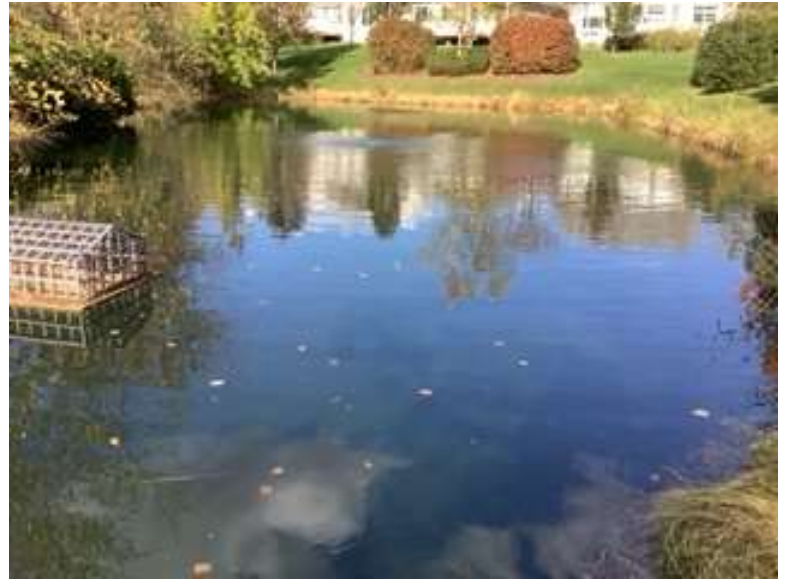
Pond 1 – Aerial view and ground level view from the perspective of the yellow arrow

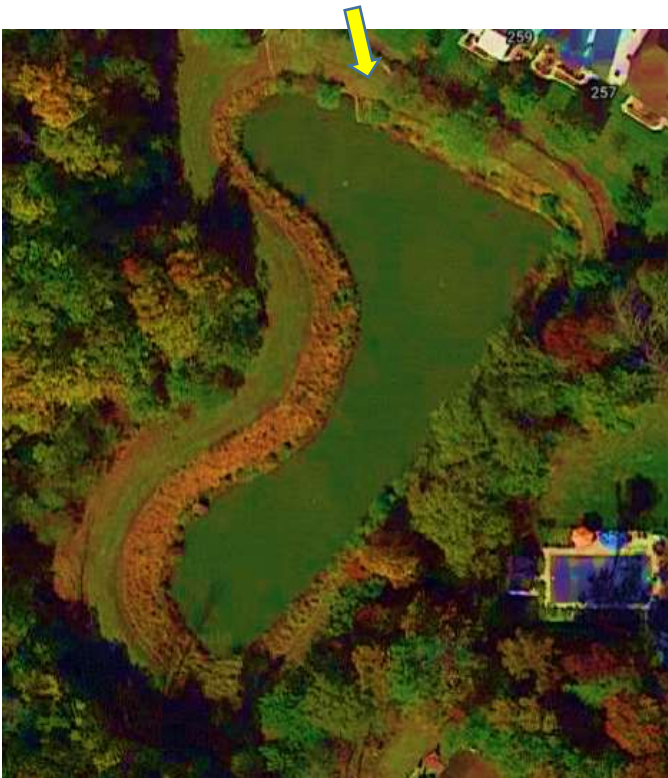
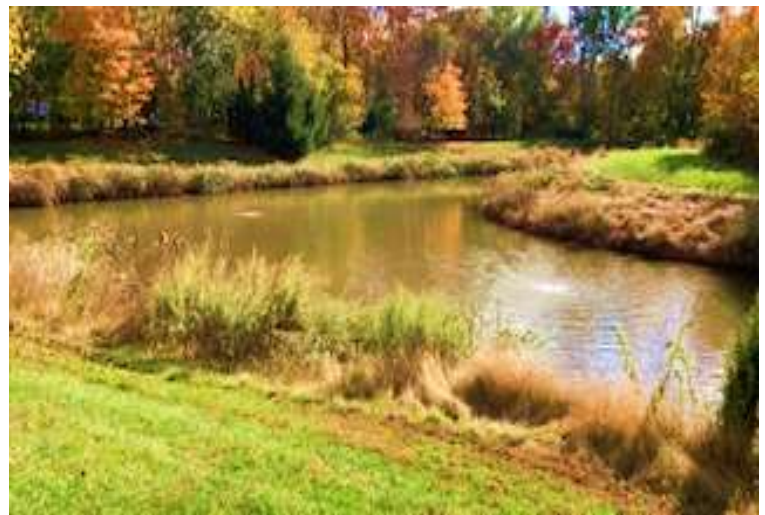
Pond 2 – Aerial view and ground level view from the perspective of the yellow arrow
